TECHNICAL MEMORANDUM

Update of the Nantucket Bicycle and Pedestrian Master Plan

**Nantucket Planning and Economic
Development Commission**

September 2005

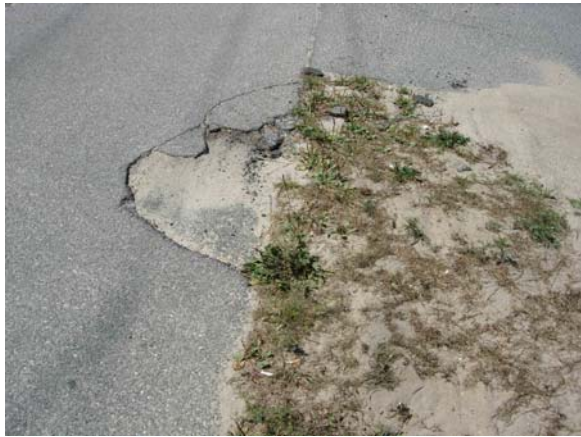
Isolated de-bonding at mile 1.2

Surface Disintegration or Debonding is present in an isolated location at approximately mile 1.2. It is recommended that the section of damaged pavement be removed and reconstructed with full depth pavement.

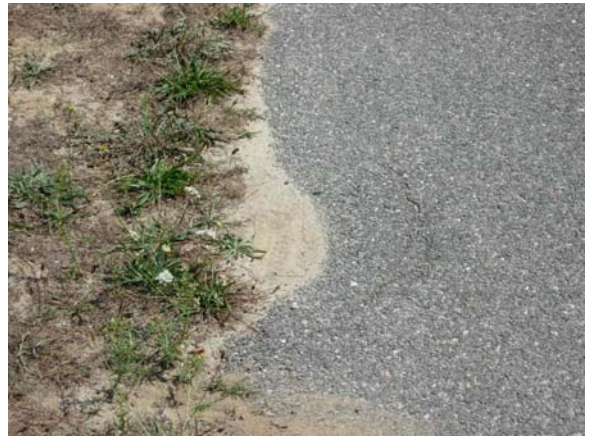
Minor Base Failure at mile 0.9

Base Failure: is occasionally present with low. At this time, it is recommended that no repairs are performed and that the pavement be re-evaluated in five years.

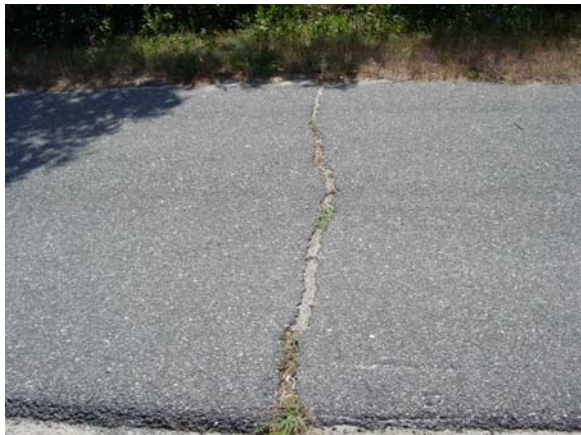
Transverse Crack at mile 2.5

Transverse Cracks are present occasionally with low to high severity. It is recommended that the transverse cracks are sawed and sealed. It is estimated that there are approximately 10 cracks per section that need to be repaired.

Quantity = 10 cracks per section x 8 linear feet per crack x 8 sections = 640 LF
Cost = 640 LF x \$5.50/LF = \$3520.00

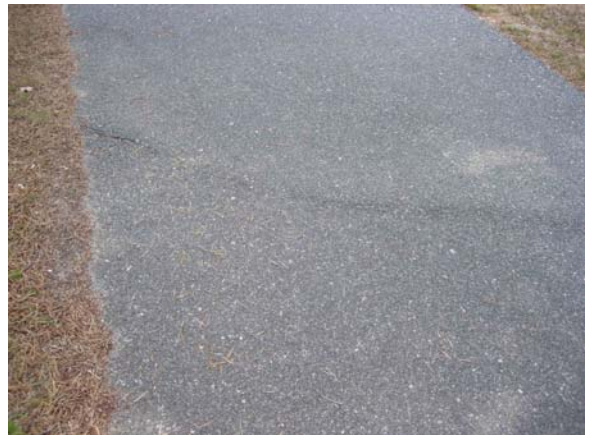
Minor upheaval caused by tree roots at mile 3.5

Pressure Damage / Upheaval is generally not present with the exception of an isolated location at mile 3.4. At this time, it is recommended that no repairs are performed and that the location is re-evaluated in five years.

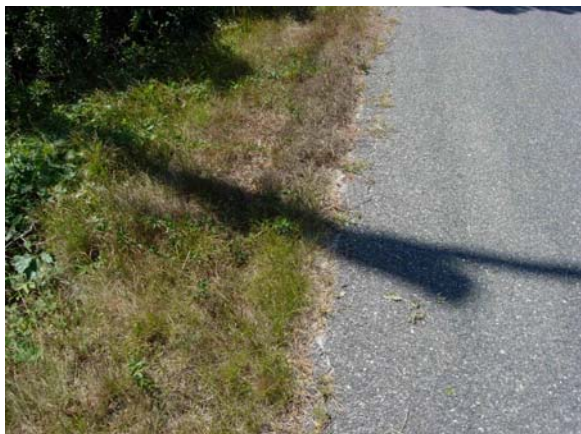
Minor edge cracking at mile 4.3

Edge Cracking is present occasionally with low to medium severity. However in test section 1 the edge cracking is extensive. At this time no repairs are recommended to correct the edge cracking.

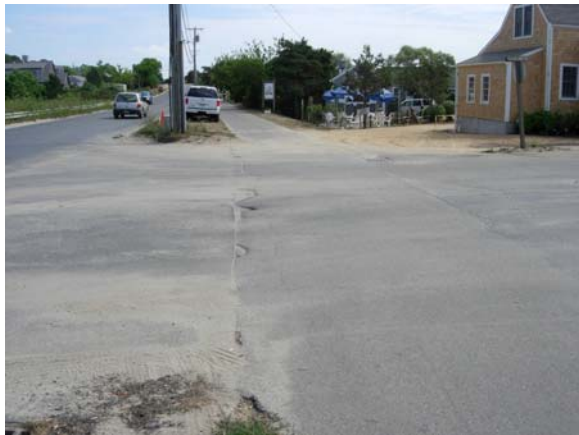
Minor de-bonding at Miacomet Avenue

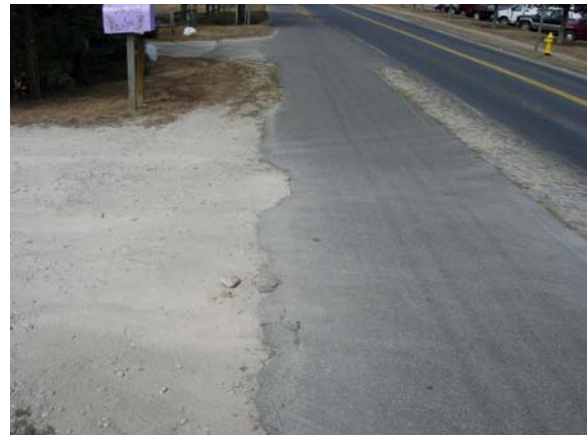
High severity edge cracking at intersecting driveway (typical)

Edge Cracking is present occasionally with low severity. However, at a few intersecting non paved driveways, the edge cracking could be considered high severity. At this time no repair is required, however when the path is eventually repaved, the aprons to abutting driveways should be extended to avoid this problem in the future.

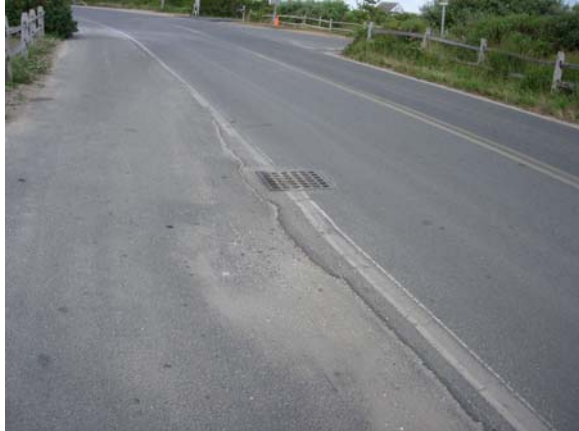
Settlement at catch basin mile 0.6

Settlements are present occasionally with low severity. Settlement generally occurs adjacent to the roadway pavement. These areas should be repaired with full depth pavement.

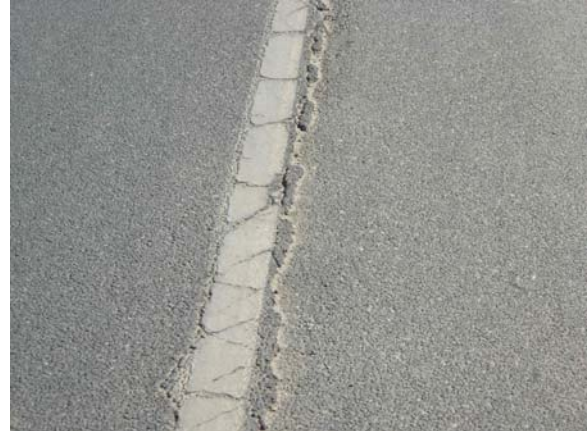
Typical edge cracking at joint
between roadway and bike path

Edge Cracking is present occasionally with low to medium severity. At this time, no repairs are recommended.

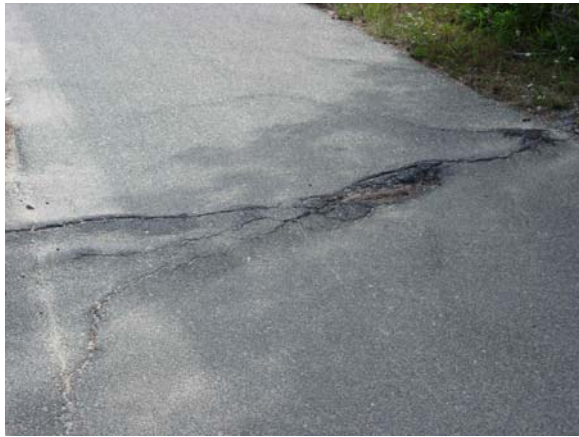
High severity upheaval caused by tree roots

Pressure Damage / Upheaval is present occasionally with low to high severity. Isolated locations at mile 2.6 and mile 3.2 to 3.4 should be overlaid.

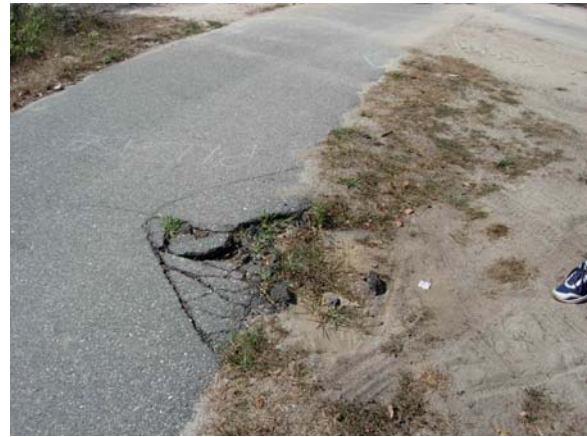
Base failure along edge mile 3.4

Base Failure is present occasionally with low severity. With the exception of an isolated location at mile 3.4, no repairs are necessary at this time. The isolated section should be repaired with full depth pavement.

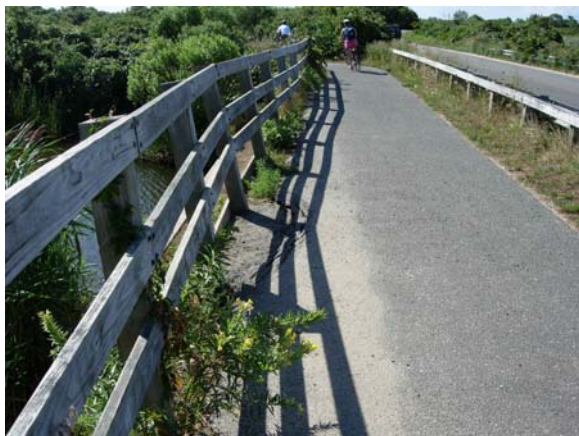
Base failure and possible
retaining wall failure at Long Pond

In addition to the repairs listed above, the wooden retaining wall at the culvert for Long Pond appears to be failing. This in turn is causing a base failure along the edge of the path. The wall

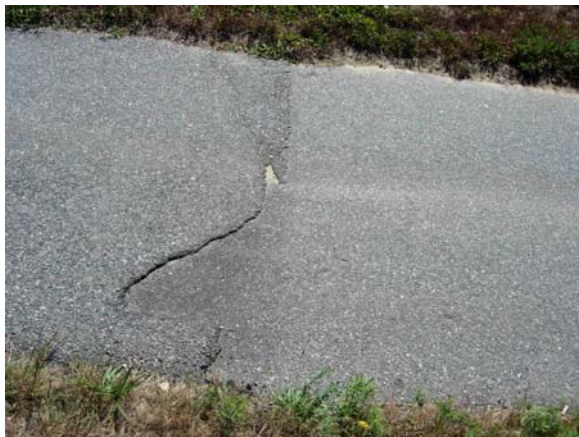
Debonding of overlay at Deacon's Way

Surface Disintegration or Debonding is present at an isolated location at Deacons Way. No repairs are recommended at this time, however when overlays are performed, a key way should be constructed so that layers of pavement can butt against each other producing a solid joint.

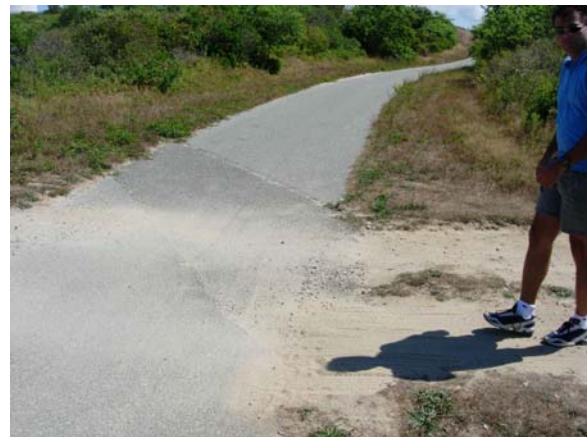
Minor settlement of utility trench at mile 0.4

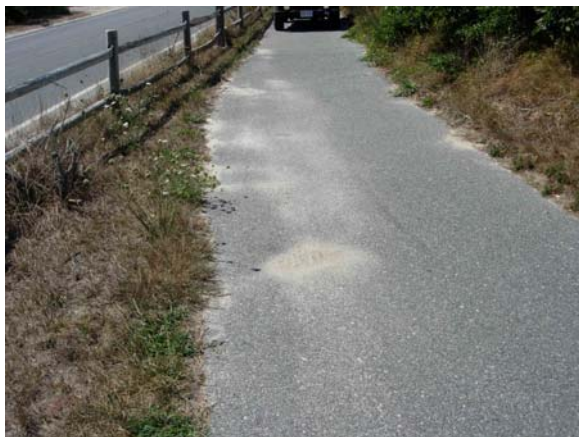
Minor base failure at mile 1.1

Base Failure is present occasionally with low severity. No repairs are recommended at this time.

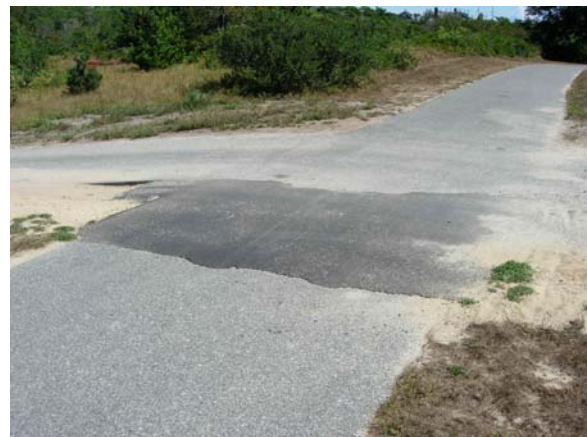
Utility patch at mile 1.1

Patching is present at two isolated locations. No repairs are recommended at either location; however, they should be re-evaluated prior to reconstruction.

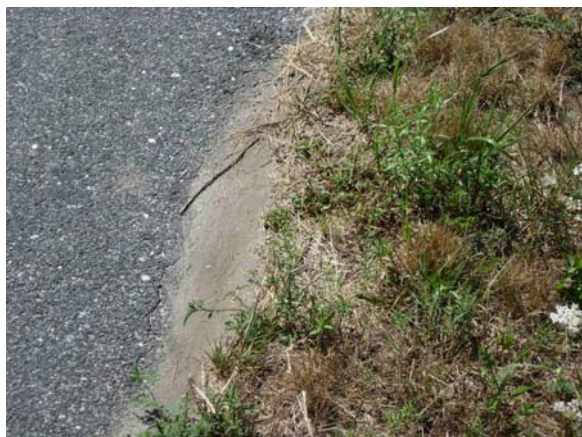
Minor base failure along edge
with minor edge cracking mile 0.5

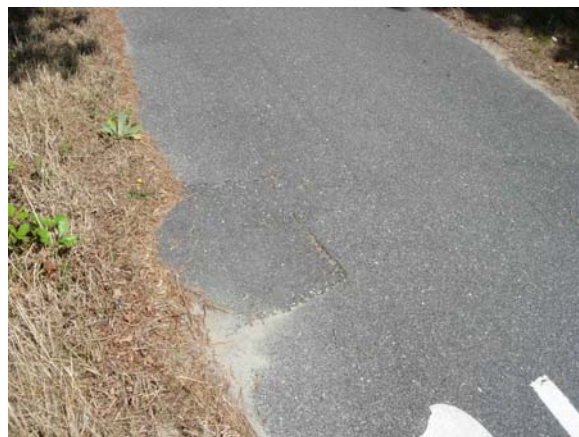
Pavement patch at mile 1.1

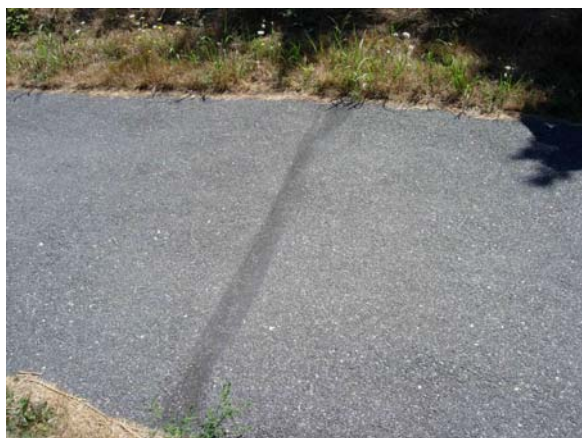
Transverse joint at mile 2.5

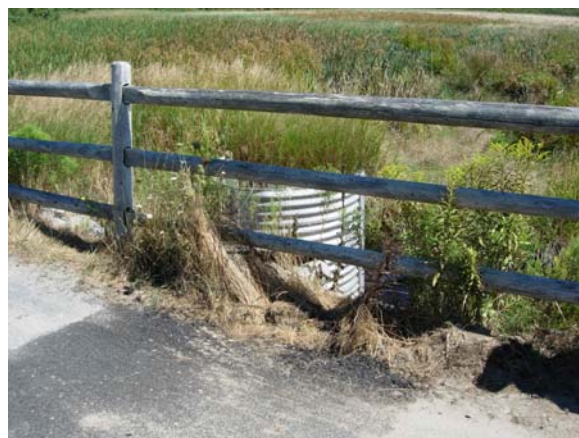
Drainage trench at mile 3.2

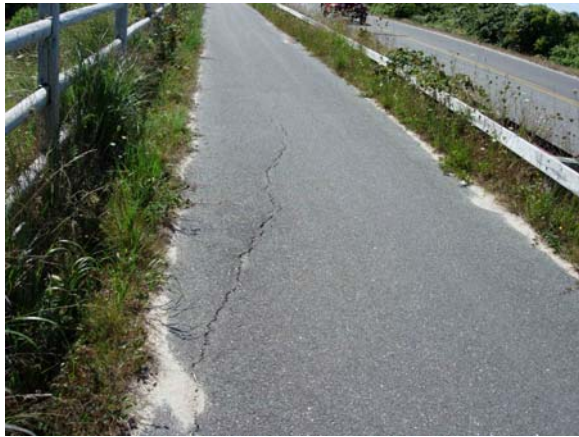
Base failure along edge mile 6.2

Base Failure is present occasionally with low to moderate severity. There are two locations where the bike path should be reconstructed with full depth pavement. These locations are at approximately mile 6.2 and mile 7.0.

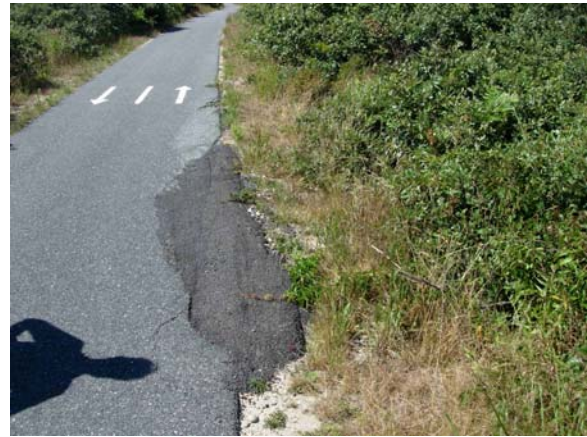
Base failure at mile 7.0

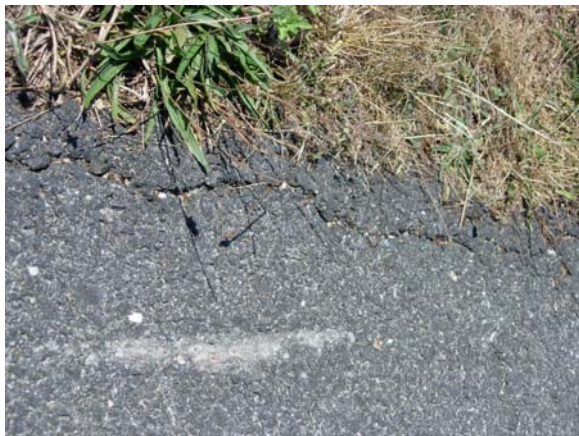
Minor edge cracking

The Eel Point Road Bike Path is in very good condition overall with very minor edge cracking in a few isolated locations. The pavement should be re-evaluated every five years. No repairs are recommended at this time.

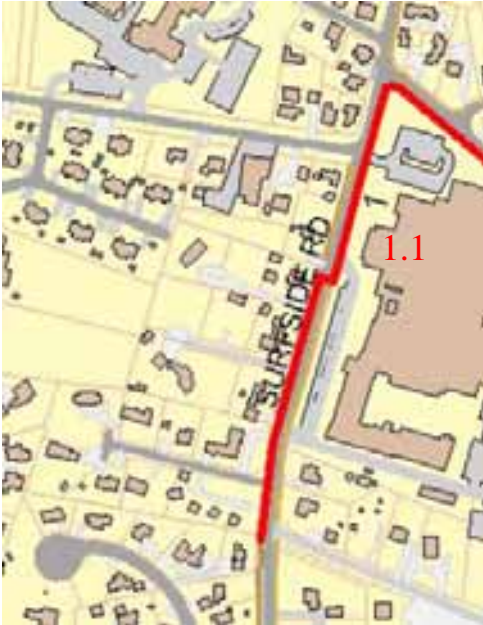
1. Surfside Road:

- 1.1 Surfside Road (*Listed as 1a in the 1994 Plan*)
 - On west side of road, beginning near First Way, widen existing 6-foot wide asphalt path by 4-feet for a distance of 600 feet to the north.
 - Install crosswalk at this location to connect to east side of road between two driveways to the High School.
 - Install Bicycle Crossing Sign (W11-1) 250 feet south of crossing on east side of road.
 - Widen existing 3-foot wide concrete sidewalk by 5 feet for a distance of 250 feet to the north.
 - Construct a bicycle path connecting Surfside Road and Sparks Avenue at southeastern part of intersection for a distance of 200 feet.

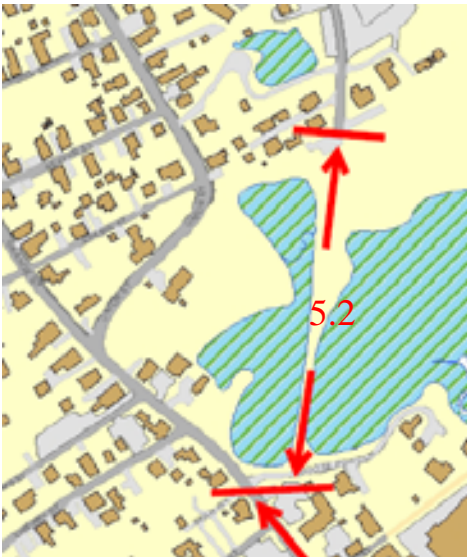
5.2 Old Railroad Right-of-Way (*listed as 1e in 1995 Plan*)

- Construct bicycle path (material to be determined) along existing berm, connecting end of Washington Street Extension to Orange Street at Bear Street intersection, a distance of 800 feet (additional easements may be needed).

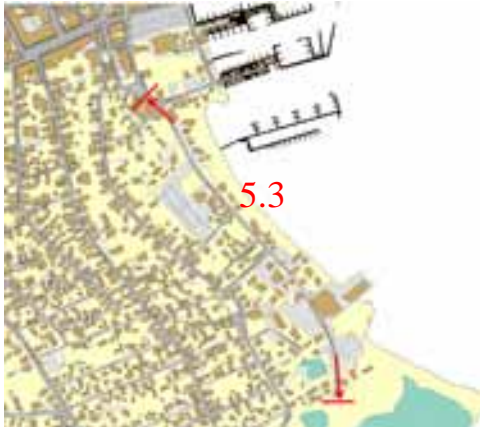
5.3 Washington St. Bicycle Route

- Designate Washington St. as a class III bicycle route with share-the-road signage between the Old Railroad Right-of-Way to Commercial St.

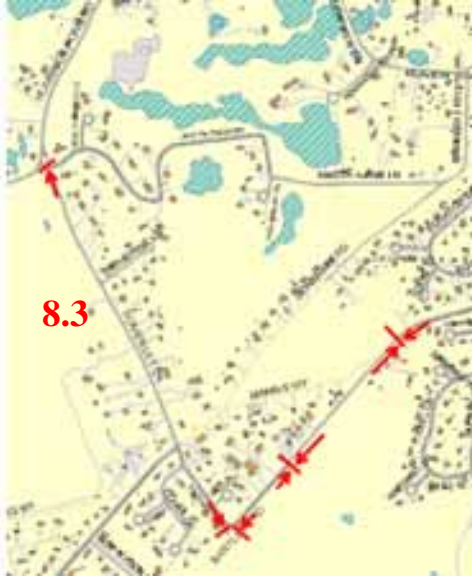
8.3 Somerset Road/Lane (*listed as 12b in 1995 Plan*)

- Designate as a bicycle route connecting Hummock Pond Bicycle Route and Bartlett Bicycle Path.

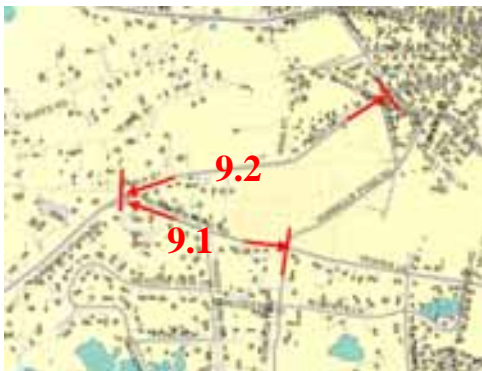
9. Hummock Pond Road and Milk Street

- Construct a 10-foot wide bicycle path along Hummock Pond Rd. from the intersection of Vesper Ln., Hummock Pond Rd., and Somerset Rd. to the intersection of Hummock Pond Road and Milk St..

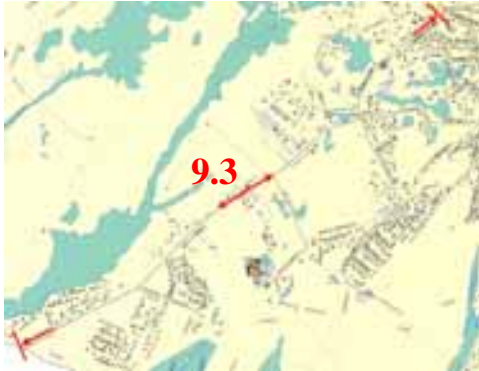
- 9.3 Hummock Pond Rd. (*listed as 13b in 1995 Plan*)
- Construct a 10-foot wide bicycle path along Hummock Pond Road between Milk St. and Cisco Beach.
 - Crossings, if needed, should be minimized.

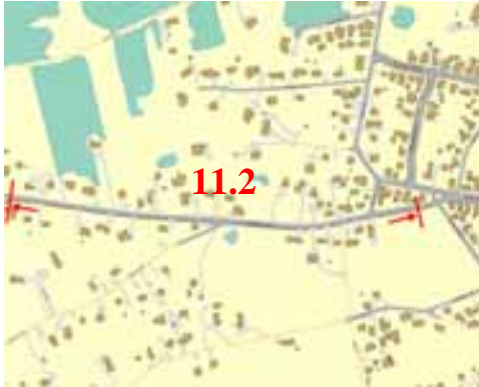
- 11.2 Areas of No-Median Separation (5,280 feet) (*listed as 14b in 1995 Plan*) (Short Term):

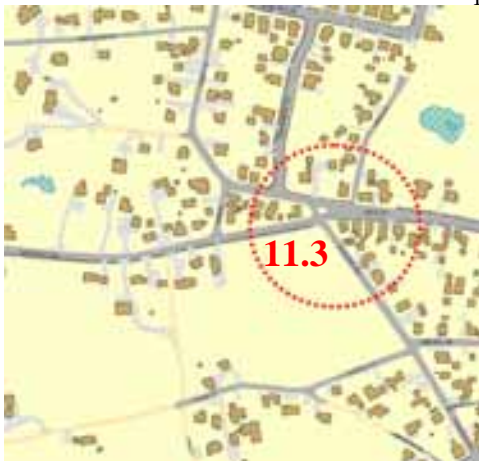
- 11.3 Improve Access to the Bicycle Facility Entrance (*listed as 14c in 1995 Plan*)
- Install crosswalk across Main Street from Caton Circle to Quaker Road.
 - Install crosswalk across Quaker Road linking existing bicycle facility with Main Street.
 - Install bicycle crossing signs (W11-1) at all approaches.
 - Widen the entrance throats and provide entering and exiting direction arrows on the pavement.

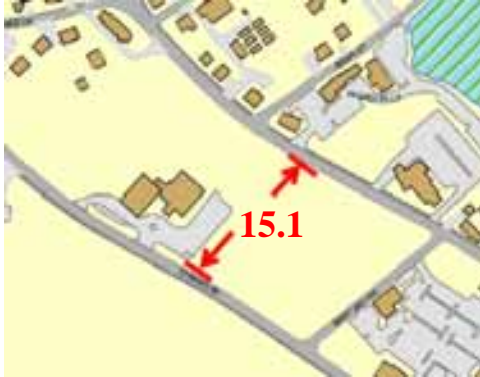
15. Boys Club Property *(listed as 1c in 1995 Plan)*

- 15.1 Boys and Girls Club between Pleasant St. and Sparks Ave.
- Construct bicycle path, 400 feet long, connecting Sparks Avenue and Pleasant Street across southeastern edge of Boys Club property (easement required).
 - Install crosswalk across Pleasant Street, linking proposed bicycle path between Boys Club site and Bear Street.
 - Install Bicycle Crossing signs (W11-1) on both sides of Pleasant Street 250 feet in advance of crossing.
 - Project is considered a low priority.
